DRAFT REPORT

SEATTLE CITY LIGHT WORK ORDER #89-6  
1989 QUARTERLY MONITORING OF THE GEORGETOWN FLUME

May 31, 1989

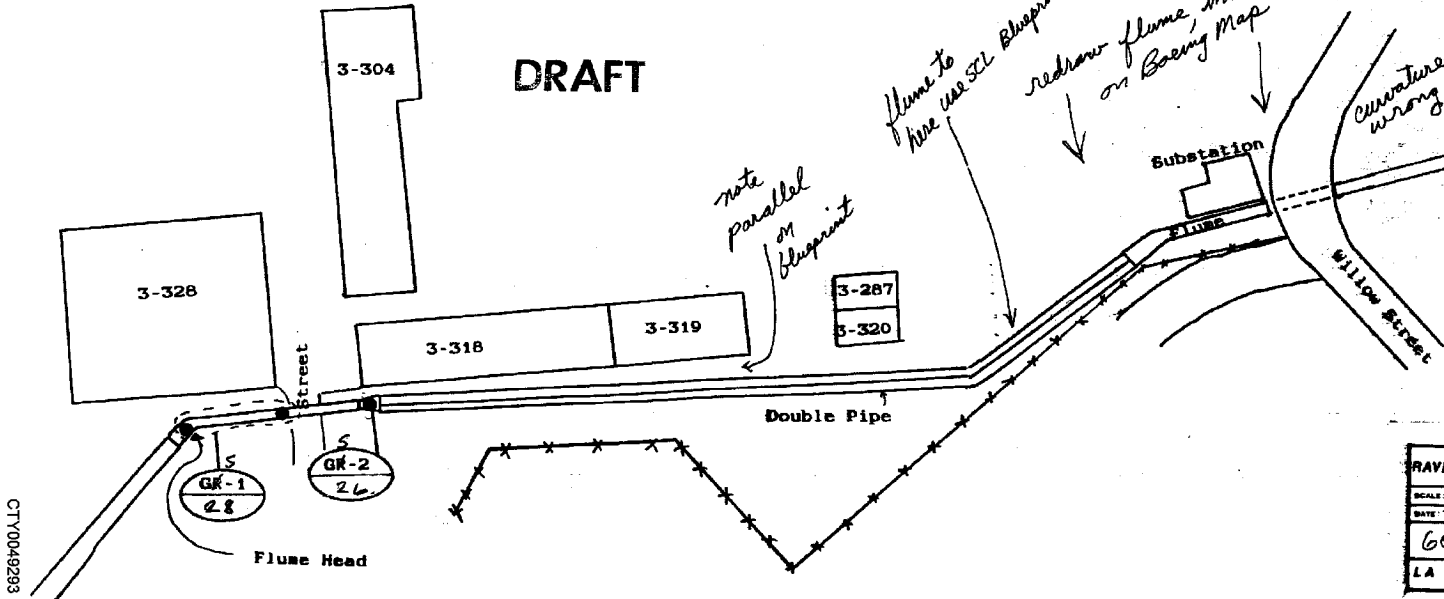
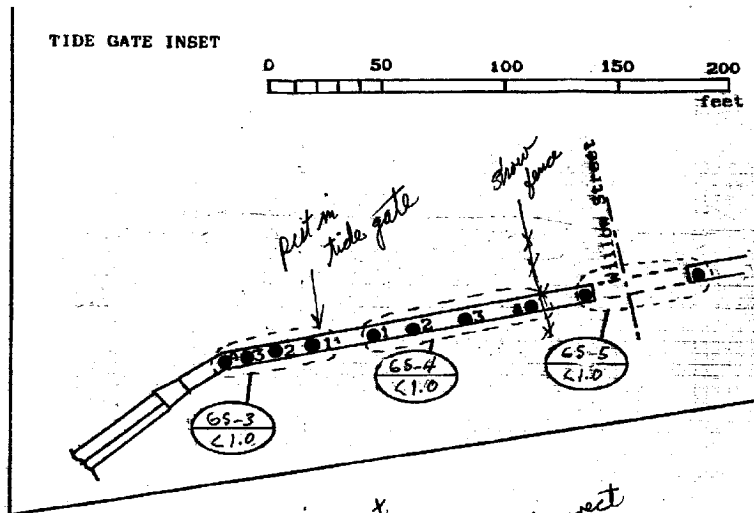
LOCATION OF SAMPLING POSITIONS, GEORGETOWN FLUME

Wood cores were specified for this project, however, since the wire mesh prevented the use of the corer upstream of Myrtle Street, a core was obtained there. Raven has since devised a corer that can sample any of the wood floor locations for future use. Sampling locations are shown in the Figure.

For the next monitoring task, we recommend that sampling at Myrtle Street be dropped, and that two wood cores are obtained between Willow Street and the double pipe mouth. The total number of samples remains at seven.
